USED ENGINE COLLECTION GUIDE

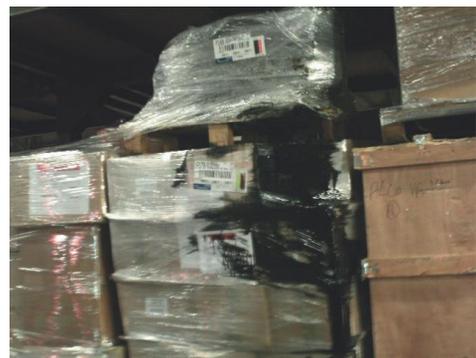
This is what can happen when engines are not shipped correctly!

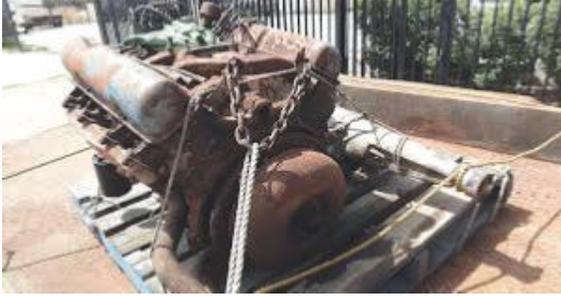
Tied with rope, **not** acceptable.

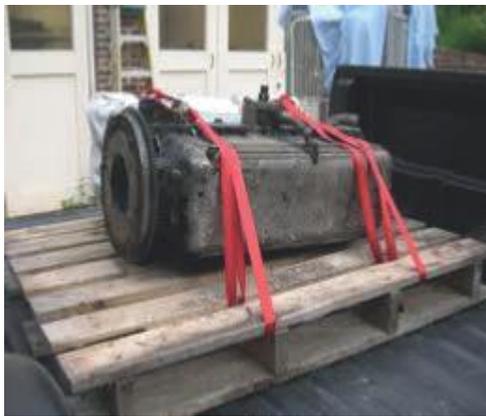
Strapped tightly to the pallet. Ideally should have rags/mats underneath, but it is drained and is a 'clean' engine, it is not wet with oil.

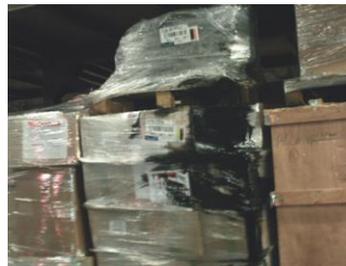
Drained, clean engine, on tyre, good pallet machine banded.

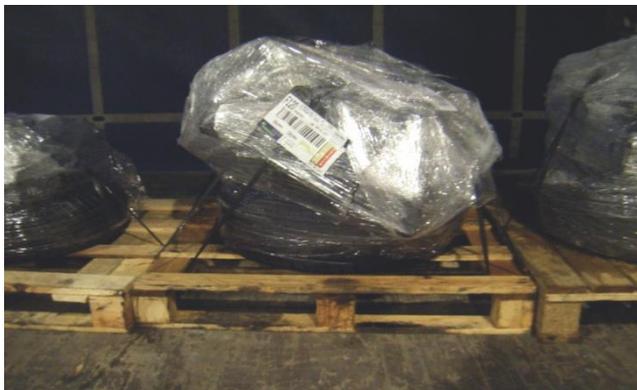
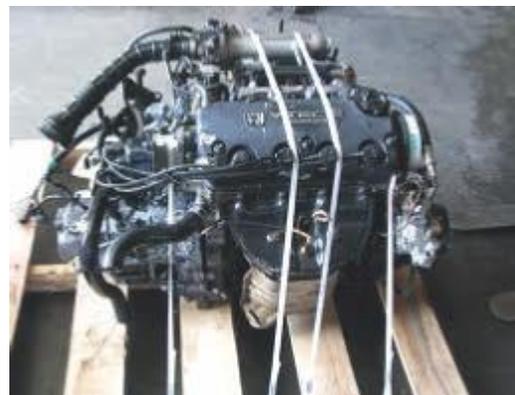
Plastic band strapped engine. 4 plastic straps done by machine and tight. Engine sits flat on pallet, no tyre needed. Ideally should be sat on rags/mat, but not needed as engine is drained, and is very clean. Straps could benefit from protection, but if bands touch smooth areas then are ok.
